Assessment of dynamic and long-term performance of an innovative multi-story timber building via structural monitoring and dynamic testing

Piotr Omenzetter^{*a}, Hugh Morris^a, Margaret Worth^a, Andrew Gaul^a, Simon Jager^a, Yohann Desgeorges^a

^aThe University of Auckland, Private Bag 92019, Auckland, New Zealand

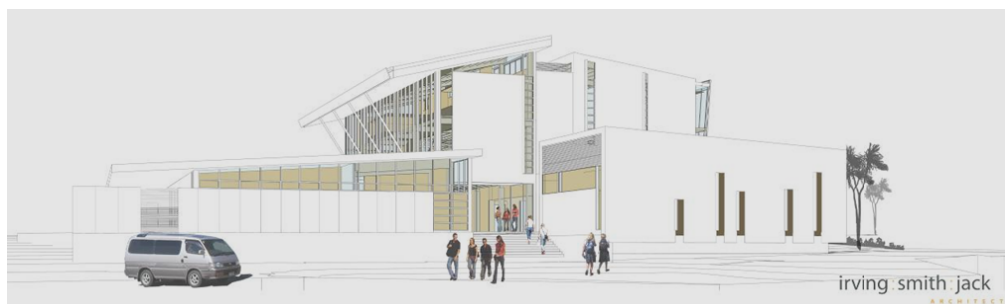
Figure 1. Nelson Marlborough Institute of Technology innovative timber building: Workshop building on the left, Media building on the right, and Arts building at the back (courtesy Irving Smith Jack Architects).

The three-story NMIT timber building was completed in January 2011. The NMIT building complex has three seismically separate sections: the one-story Media building, one-story Workshop building and three-story Arts building as shown in Fig. 1. The major building of interest is the Arts building (Fig. 2), which is a combination of staff offices and small classrooms. Structurally, the building has non-moment resisting frames for vertical loads. The key innovation is the provision of dual timber post-tensioned shear walls in both directions. The structural design was based on EXPAN technology developed by the University of Canterbury as part of Structural Timber Innovation Company consortium²². The laminated veneer lumber (LVL) shear walls are designed to rock from side to side in a major earthquake and have energy dissipating devices between the two panels of each shear wall pair. The lateral deformation is expected to be up to a maximum of 130 mm and the shear walls will uplift as much as 50 mm. The post-tensioning is provided by four 32 mm rods tensioned to 340 kN each. There is specialized detailing to allow the freedom of movement and this includes the major lateral load transfer via cylindrical connectors with Teflon spacers and slotted location bolts so that rotation does not induce moment, and U-shaped yielding steel energy dissipaters (Fig. 3). The shear walls link to the frame and lateral load is transferred through the floor diaphragm.

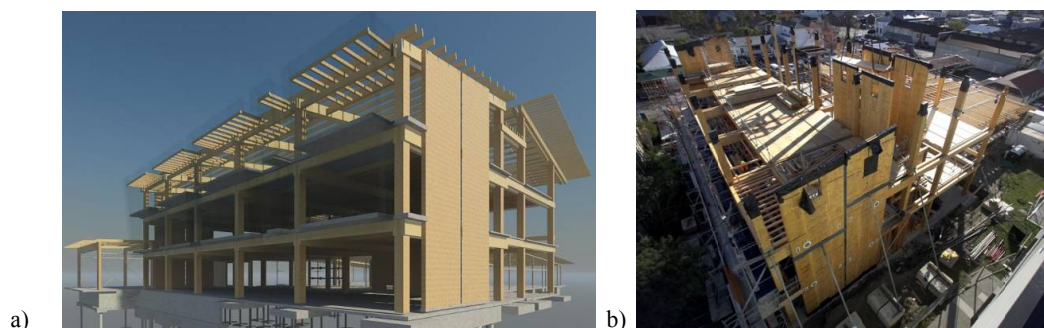
Figure 2. The Arts building: a) structural system with shear walls (courtesy Aurecon), and b) building during construction.

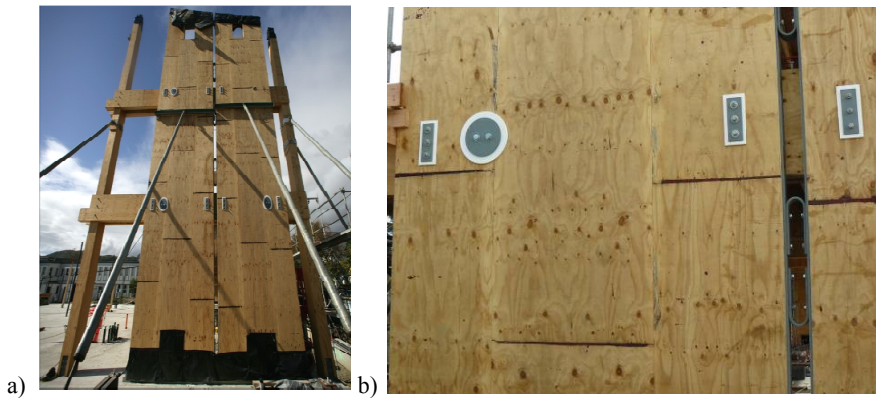
Figure 3. Post-tensioned timber shear wall: a) shear wall during erection, and b) cylindrical shear connectors with Teflon spacer, slotted location bolts and U-shaped yielding steel energy dissipaters.

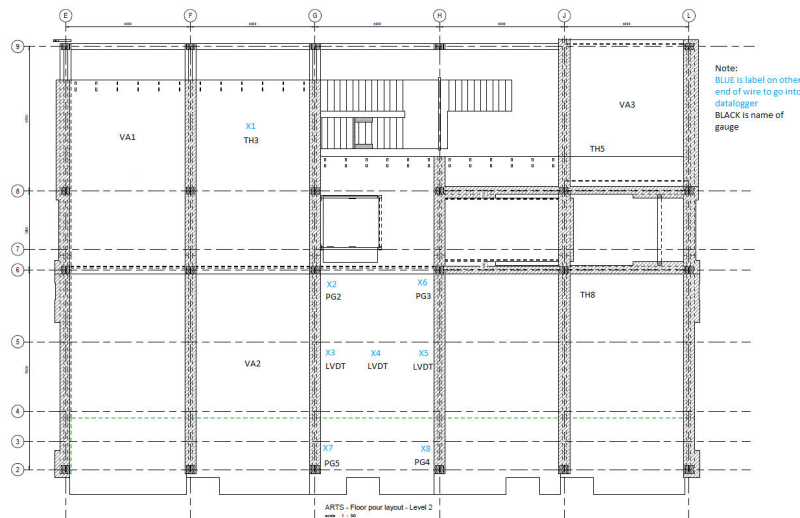
Figure 6. Locations of floor accelerometers (denoted VA1 through VA3).

Deciding on an optimal sensor placement is a common problem encountered in many engineering applications and is a critical issue in the design and implementation of an effective structural health monitoring system²⁴. Office floors are often irregular in plan, have openings, uncertain boundary conditions and complex structural systems, resulting in complex dynamics. The loading due to their usage may lead to multimodal response that needs to be captured by a limited number of strategically positioned sensors. A great deal of research has been conducted on optimal sensor placement using a variety of placement techniques and criteria. Meo and Zumpano²⁴ compared six different optimal sensor placement techniques and concluded that the effective independence-driving point residue (EfI-DPR) method, proposed by Kammer²⁵ and Kammer and Tinker²⁶, provides an efficient method for optimal sensor placement to identify the vibration characteristics. In this monitoring system design, the technique was augmented by a combinatorial search for the optimal solution²⁷. The final layout of three accelerometers, denoted in Fig. 6 as VA1 through VA3, was decided as a trade-off between the optimization results and some practicality and feasibility considerations.

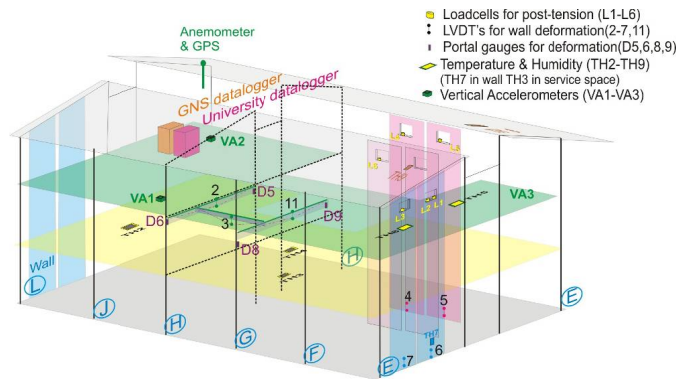
Figure 7. Instrumentation for monitoring of long-term deformations of structural timber components (shear wall sensors and floor accelerometers also shown).

The components of this system are mainly located in the Arts building and their locations are shown in Fig. 7; some additional sensors were also installed in the Media building. Note Fig. 7 also shows long-term shear wall sensors and floor accelerometers, as all these sensors were collected to a National Instruments 533 MHz CRIO-9022 data logger installed by the University of Auckland. Several temperature and humidity sensors were positioned in close proximity to the monitored structural components. The long-term floor sag is monitored with LVDTs using a taut-wire baseline system for the measurement reference²⁸. As shown in Fig. 8, a catenary wire is hung over a pulley, in between the 750 mm deep beams with a 40 kg mass to maintain constant tension so that temperature compensation is not necessary.

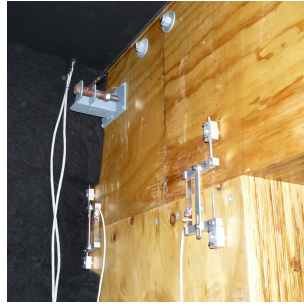
Figure 9. Monitoring knee rotations with “portal” strain gauges.

The Media building has four simple haunched portal frames that are a modest span. As shown in Fig. 9, the instrumentation uses linear “portal” type strain gauges to determine crushing and joint rotation with a vertical LVDT connected to a baseline wire to monitor deformation. Clearance limits mean that a trolley could not be used and the tip of the LVDT is directly fixed to the wire.

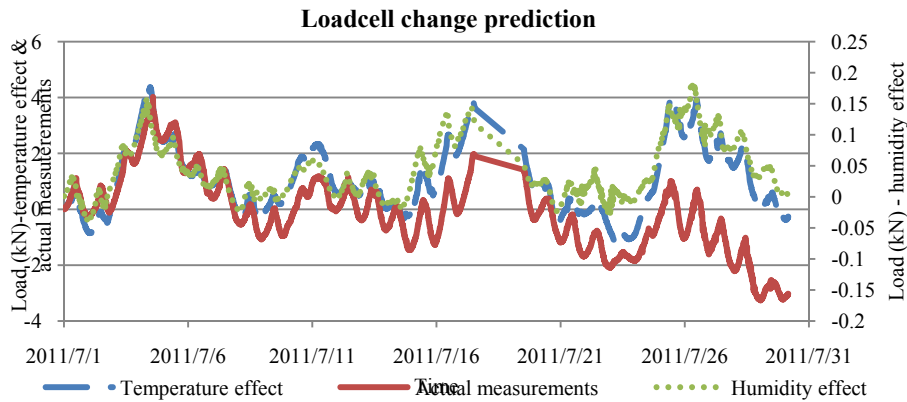
Figure 10. Load prediction from temperature and humidity variation compared with measured post-tension.

Figure 10 shows the analysed load change values due to temperature and humidity compared to the measured load changes over a month. Note that the load scale for temperature is 20 times the load scale for humidity. The temperature effect is much more significant and correlates very closely with weekly prediction. The effect of humidity is about 5% of the temperature effect and has a slightly lower direct correlation. Over the month, the temperature and humidity effects result in a zero change. The trend for the actual load is a loss of 3 kN.

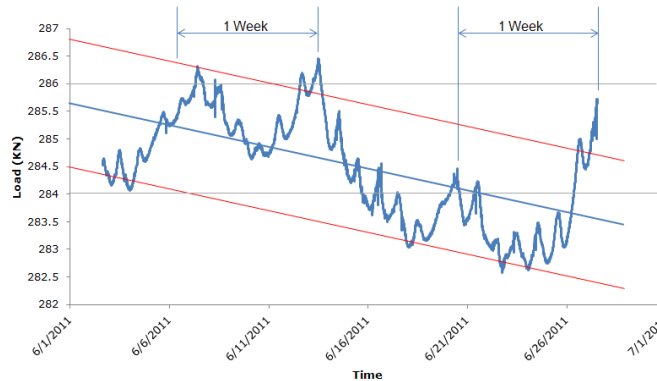
Figure 11. Post tension load trend for load cell LC6 over a month showing daily and weekly variation.

As outlined in Table 2, loads changed reasonably consistently with the deformation change. The values for one load cell over a month are shown in Figure 11 which highlights the daily and weekly variations. (The heating was turned off for the weekend). The trend of the load changes is shown by plotting the difference from the value at 1 April in Figure 12.

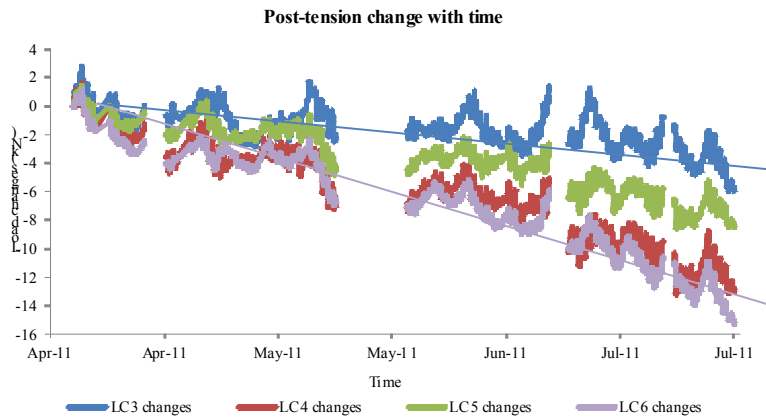
Figure 12. Post-tension load changes over 4 months showing range of trends.

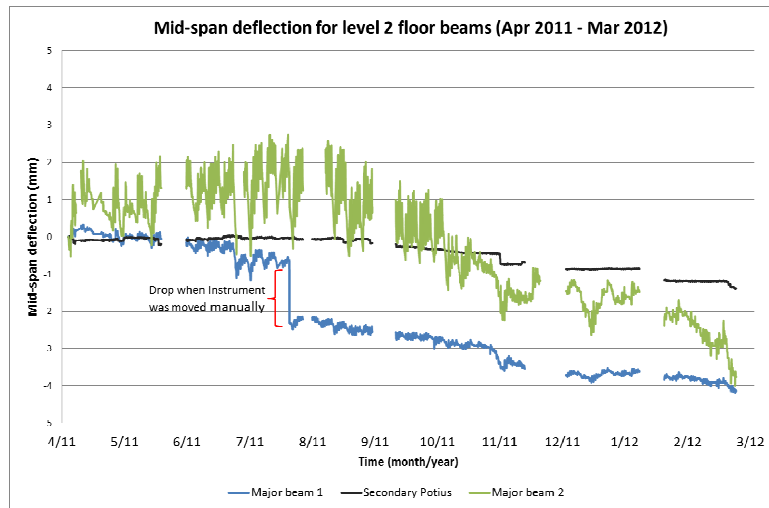
Figure 13. Long term deflection changes since April 2011.

Figure 13 plots the long term deformation from April 2011 to March 2012. It shows the major composite beams have a larger creep deflection compared to the secondary non-composite Potius floor beam. Over almost a year, the composite beams had a deflection of 3 to 4 mm over a 9.6 m span and the non-composite beam had 1 mm over a 5.5 m clear span. This is equivalent to 30% and 15% of their respective theoretical elastic deflections due to gravity load only. The overall trend is increasing in downward deformation, the deformation variation synchronized closely with the humidity variation.

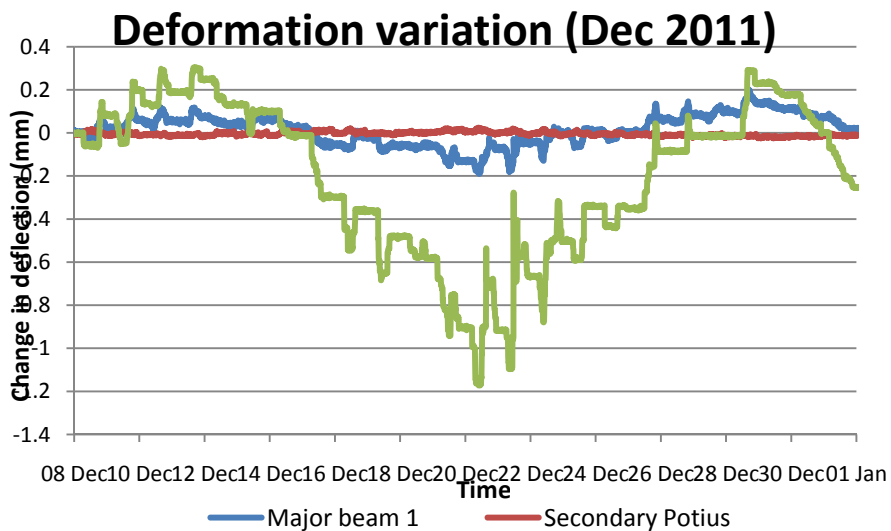
Figure 14. Daily and weekly variation of floor deformation - Dec 2011.

Figure 14 is a plot of typical daily variations which was as much as 1.0 mm in July; the weekly pattern is also visible with significant changes at weekends. Deflection variation is predominantly due to environmental changes with some possible influence from live load changes. This figure shows that the composite beams have larger variation compared to the non-composite Potius secondary beams, because they respond more to the environmental factors. The environmental factors are similar for the two major beams, but the live load situation is different with two different rooms above them.

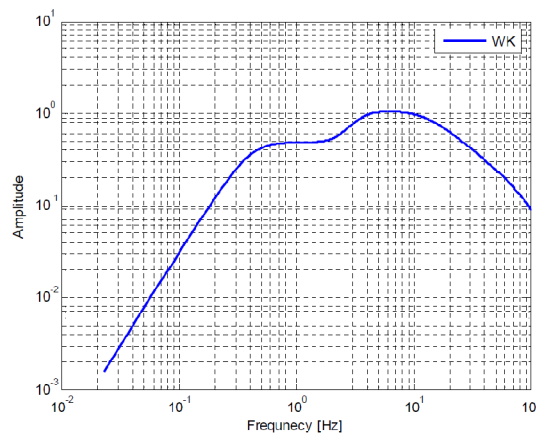
Figure 15. Magnitude of frequency weighting function W_k for vertical vibrations.

person, ISO2631-1:1997(E)²⁹ requires raw measured acceleration to be frequency weighted to account for the variable sensitivity of humans to vibrations. Frequency weighting W_k , a complex function of frequency whose magnitude is shown in Fig. 15, is to be applied to vertical vibrations producing weighted acceleration $a_w(t)$. Vibration levels for comparison with acceptable limits are to be calculated using frequency weighted data. It can be seen from Fig. 15 that vibrations in the range of frequencies between 0.7 Hz and 13 Hz would be perceived particularly strongly.

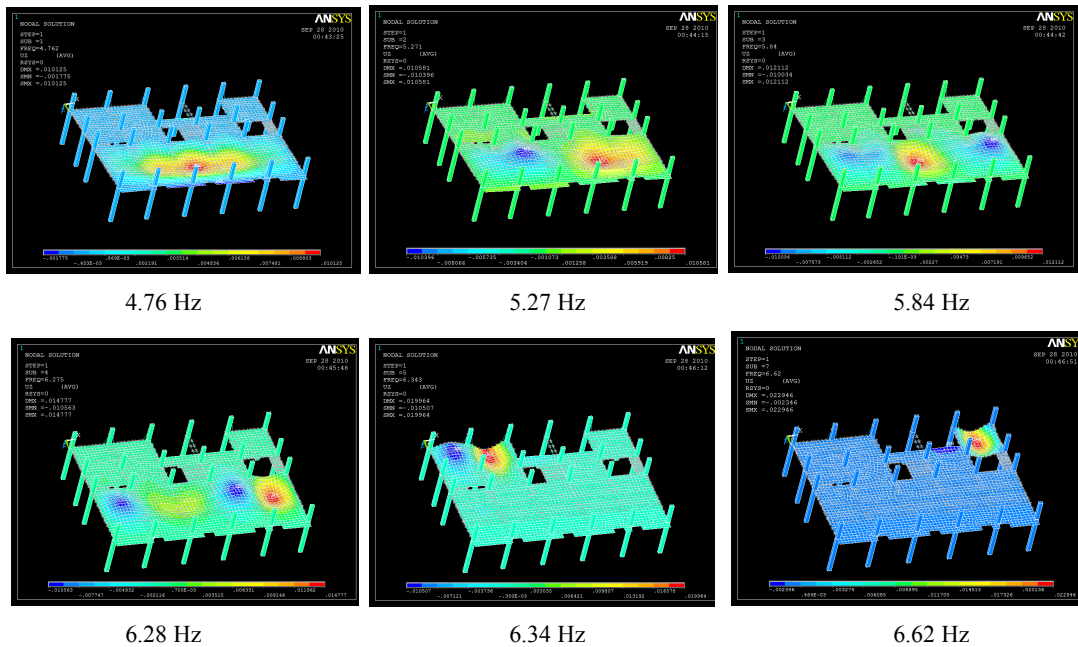
Figure 16. Selected lowest modes of floor vibrations by FEM analysis.

The floor was modeled using the FE software ABACUS. The LVL beams were modeled using beam elements and concrete topping using shell elements. Columns of the stories above and below were also included in the model to take into account their influence on floor vibrations. Young's modulus and density were 10.7 GPa and 570 kg/m³ for timber and 30 GPa and 2,400 kg/m³ for concrete, respectively.

Modal analysis revealed that there were 22 modes below 12.5 Hz. These are in the range that could be excited by footfall harmonics and also in the range of elevated human perception (see Fig. 15). Figure 16 shows several of the lowest frequency modes. It can be seen that due to irregularities and openings in the floor they are localized in either the lower part of floor, where several small classrooms are located, or in both upper corners used for offices and galleries.
